PILATUS

Service Bulletin No. 62B
(Supersedes No. 62A)

Subject: Flettner tabs V-14463
Models affected: PILATUS PORTER PC-6/ all models
Time of compliance: None

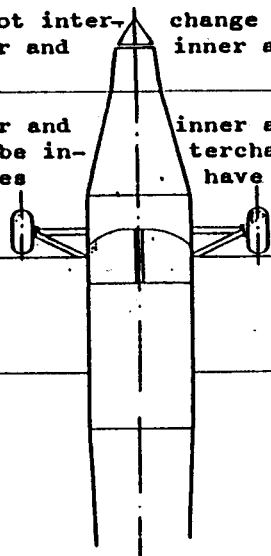
Identification of ailerons for PC-6, all models

Approved variant	Design	left hand wing		Drawing No.	right hand wing		
		outside	inside		inside	outside	
1	without Flettner tabs	Ailerons not reinforced, without hinges for Flettner tabs (existing version)	6106.10	6106.10	Model 6106.34 may be used instead of 6106.10 but not reverse.	6106.10	6106.10
2		As variant 1 but hinges for Flettner tabs fitted (without reinforcement)	6106.10 Rub. I	6106.10 Rub. II		6106.10 Rub. I	6106.10 Rub. II
3	with Flettner tabs	Outer ailerons reinforced; hinges for Flettner tabs fitted	6106.34 Rub. I	6106.10 Rub. II	Do not interchange outer and inner ailerons	6106.10 Rub. I	6106.34 Rub. II
4		Outer and inner ailerons reinforced and provided with hinges for Flettner tabs	6106.34 Rub. I	6106.34 Rub. II		Outer and inner ailerons may be interchanged if hinges have been changed	6106.34 Rub. I

Note: "Rub. I" and "Rub. II" refer to position of hinges for Flettner tabs.
